BoorYul-Bah-Bilya Mandoon Bilya (Helena River)

Baseline Surface Water and Sediment Sampling 2024

April 2025

Bibbul Ngarma Aboriginal Association Incorporated

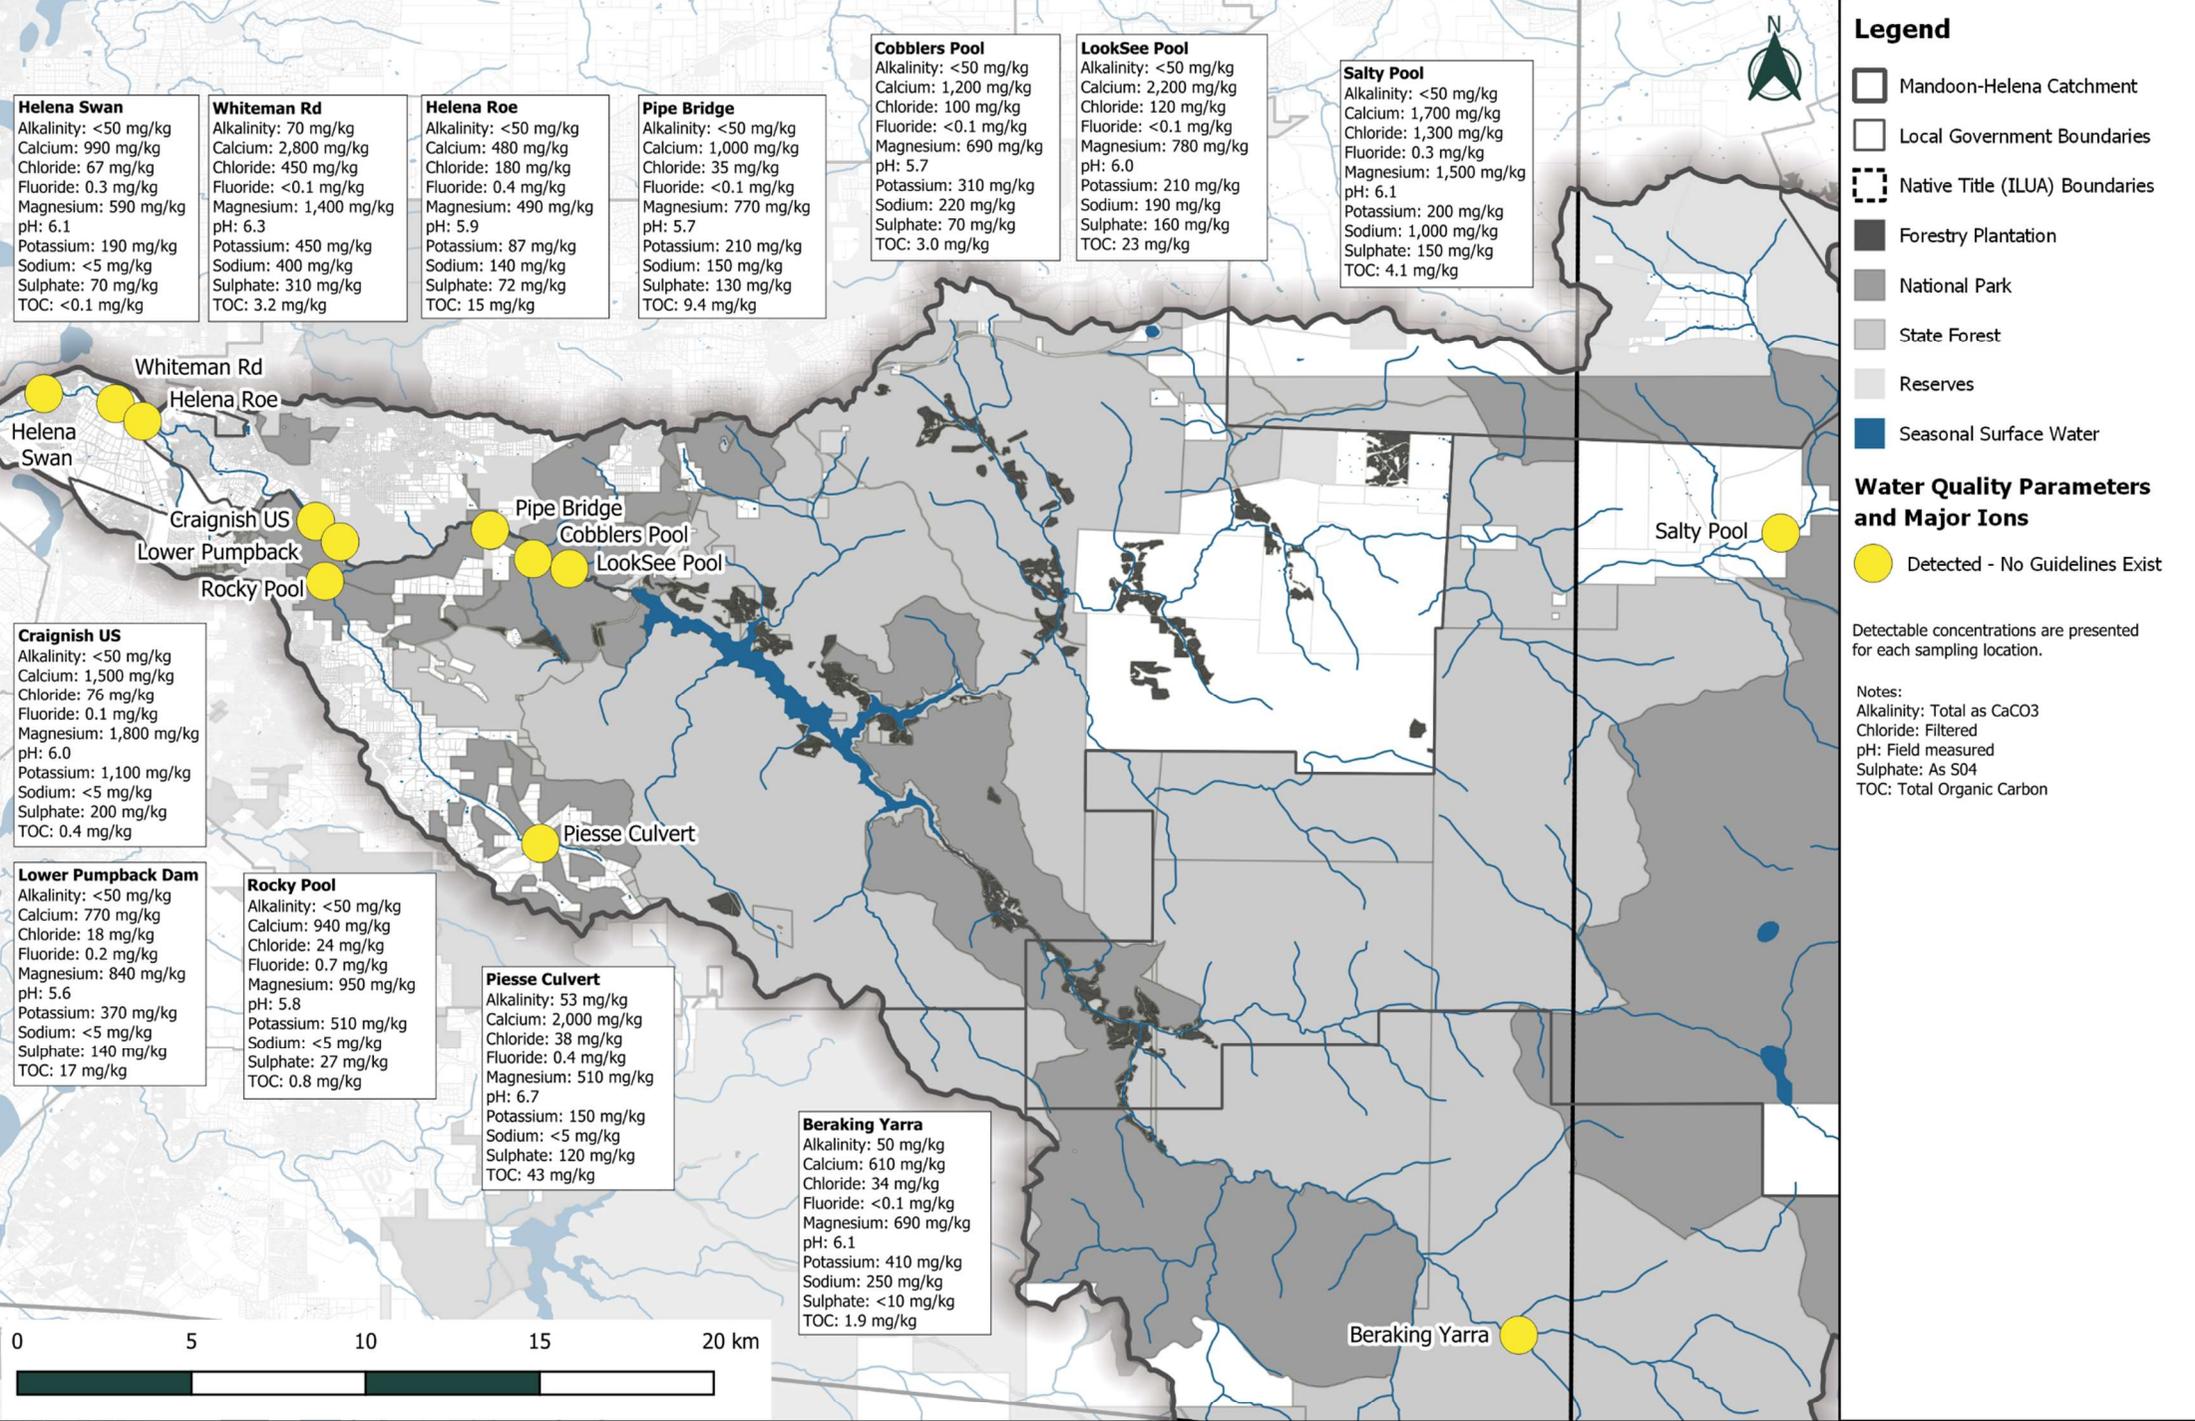
Figure 6 Sediment Sampling Results: Water Quality Parameters and Major Ions

Most water quality parameters are not applicable to sediment although samples were analysed for alkalinity, moisture content. pH and TOC (refer **Figure 6**).

DGV do not exist for major ions in sediment.

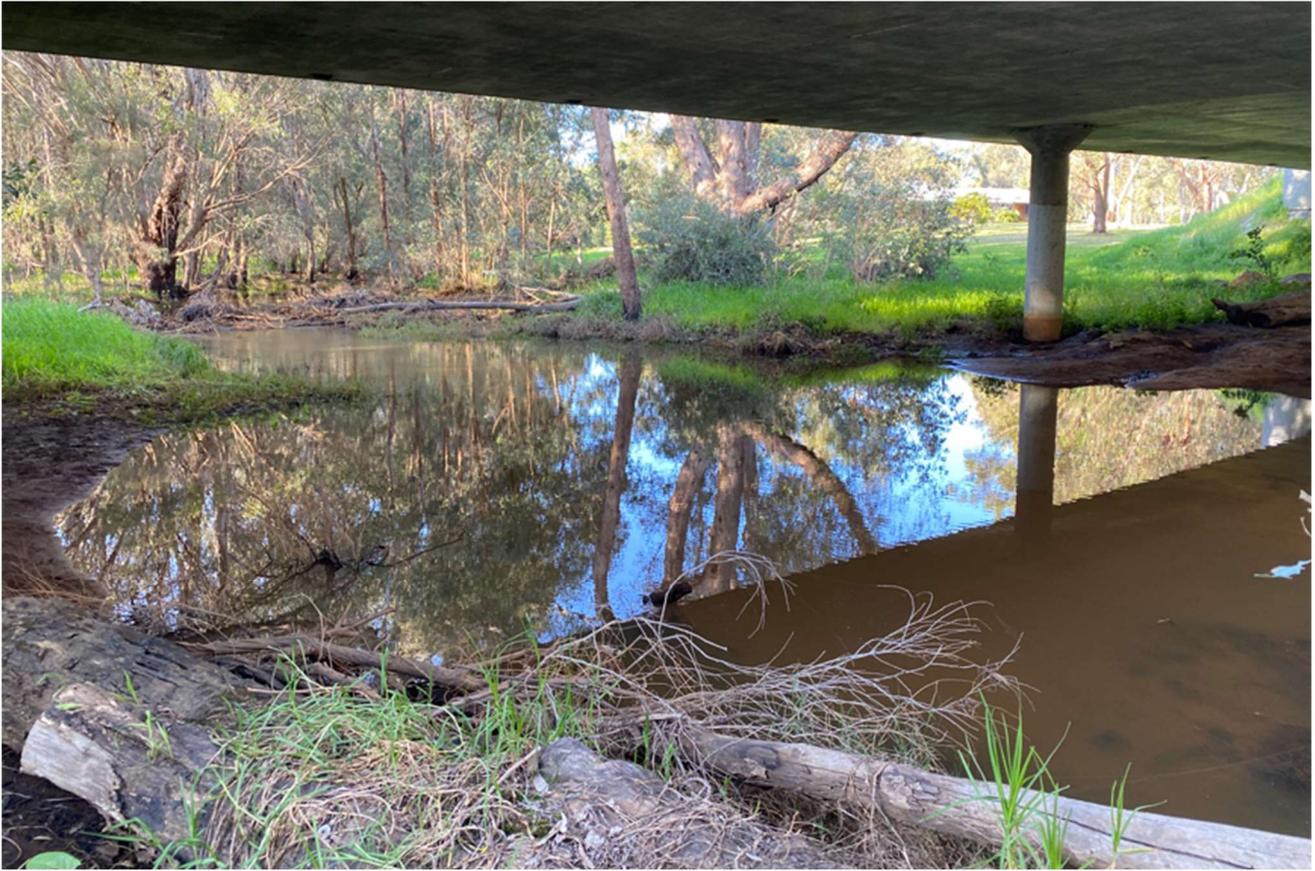
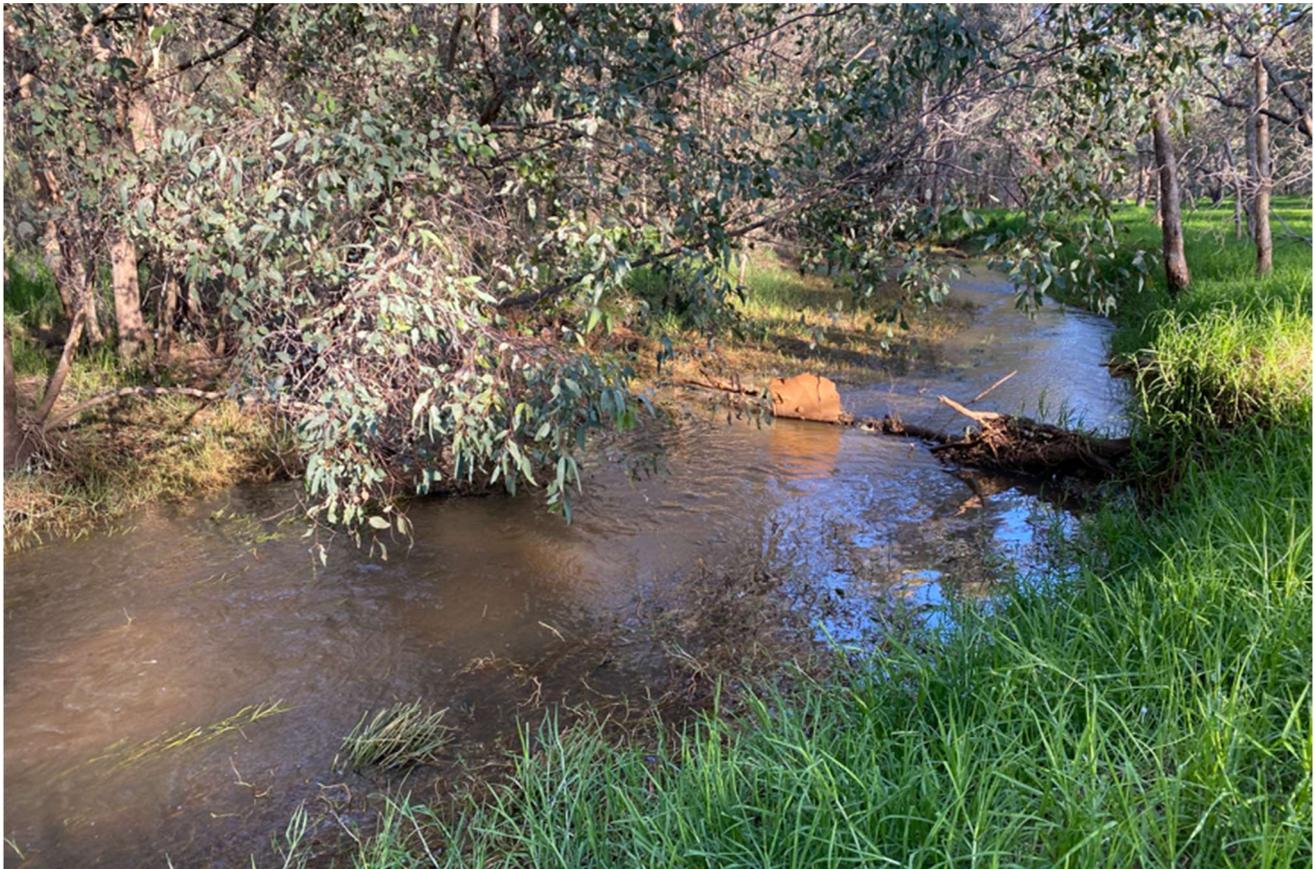
Sediment Results	
<ul style="list-style-type: none"> • Metals and nutrients detected above the LOR. • Pesticides, herbicides, hydrocarbons, surfactants, volatiles and PFAS compounds not detected. 	
Sediment – Sediment Quality DGV Exceedances	
<ul style="list-style-type: none"> • No exceedances of the DGV, although limited DGV exist to enable screening.

Helena Swan Standing under Bushmead Rd bridge looking upstream at sample site

Helena Swan Immediately downstream of Bushmead Rd bridge looking downstream to Riverbank Reserve

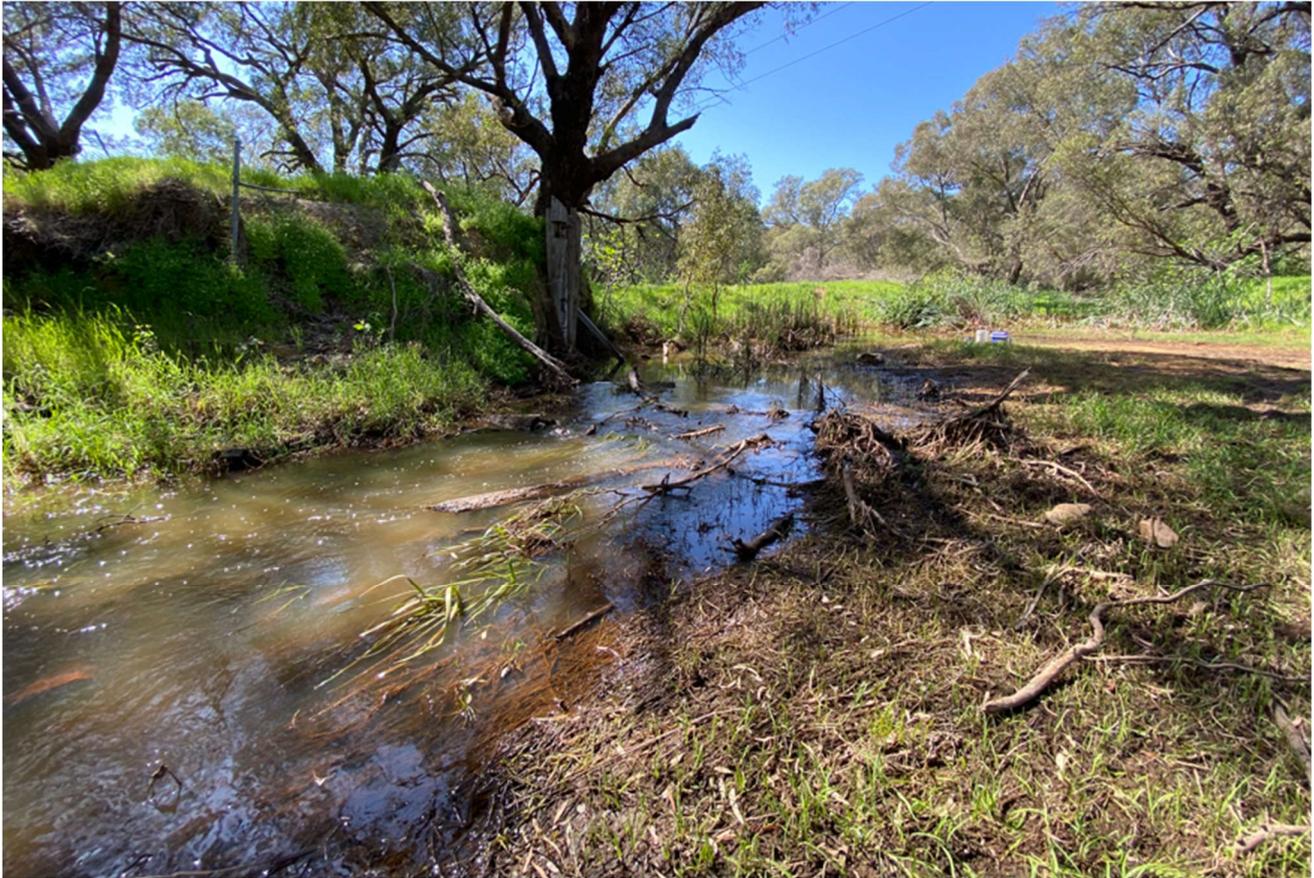
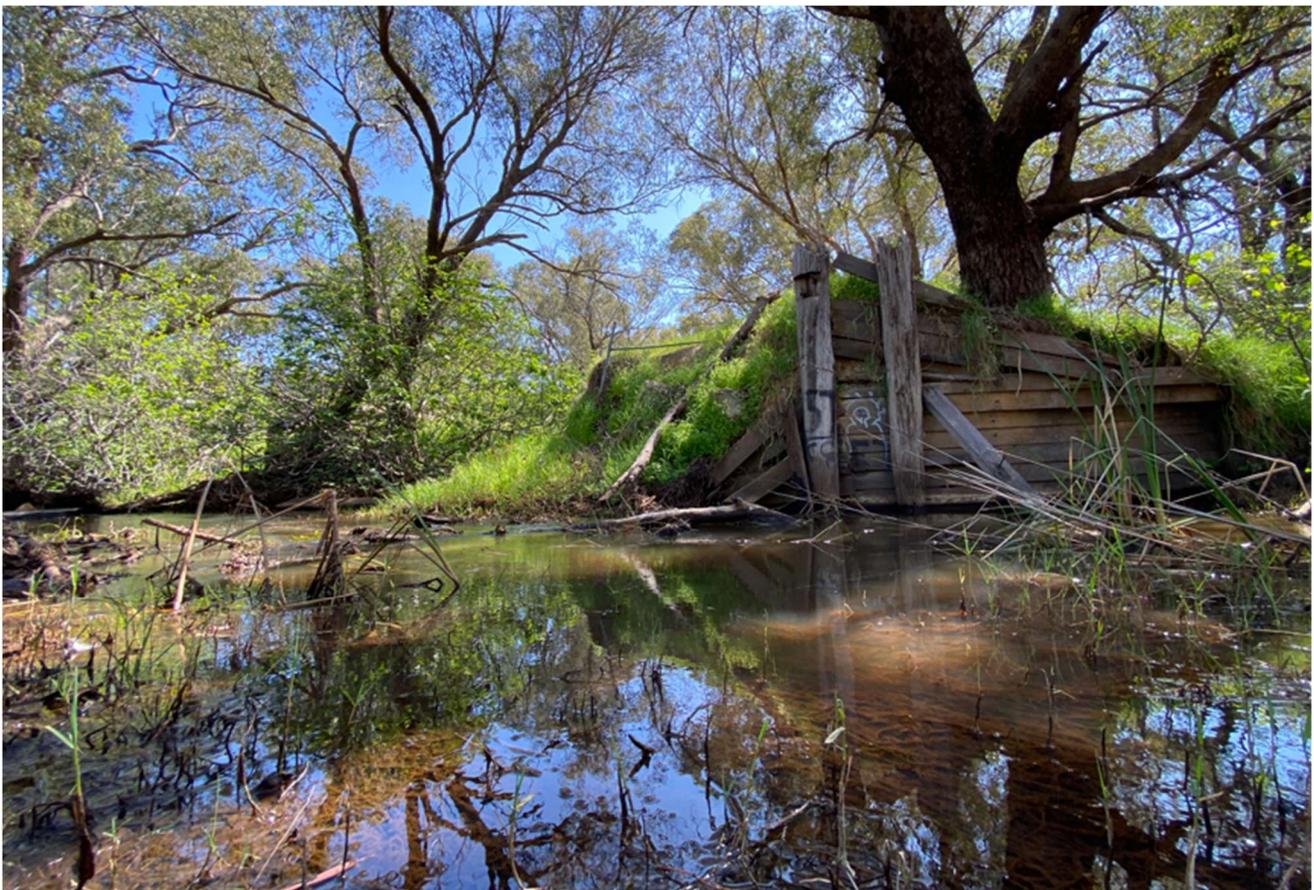
Sediment Results	
<ul style="list-style-type: none"> • Pesticides, hydrocarbons, metals, nutrients and surfactants detected. • Herbicides, volatiles and PFAS compounds not detected above the LOR. 	
Sediment – Sediment Quality DGV Exceedances	
<ul style="list-style-type: none"> • TRH C10-C40 at 335 mg/kg above a DGV of 280 mg/kg. • Mercury at 0.23 mg/kg above a DGV of 0.15 mg/kg. • Naphthalene at 0.7 above a DGV of 0.16 mg/kg.

Whiteman Rd Standing at location of former Whiteman Rd bridge, looking upstream

Whiteman Rd Standing at location of former Whiteman Road bridge, looking downstream

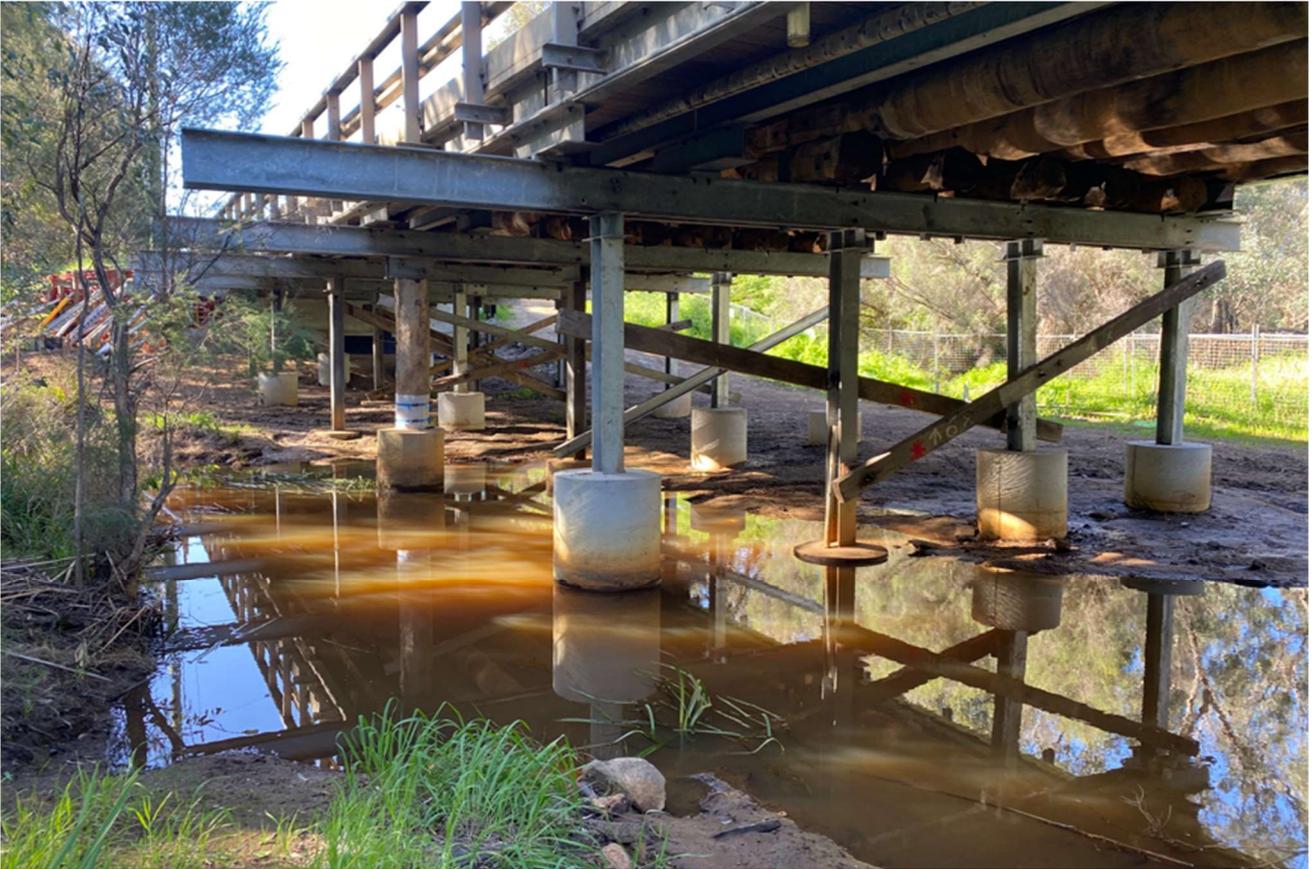
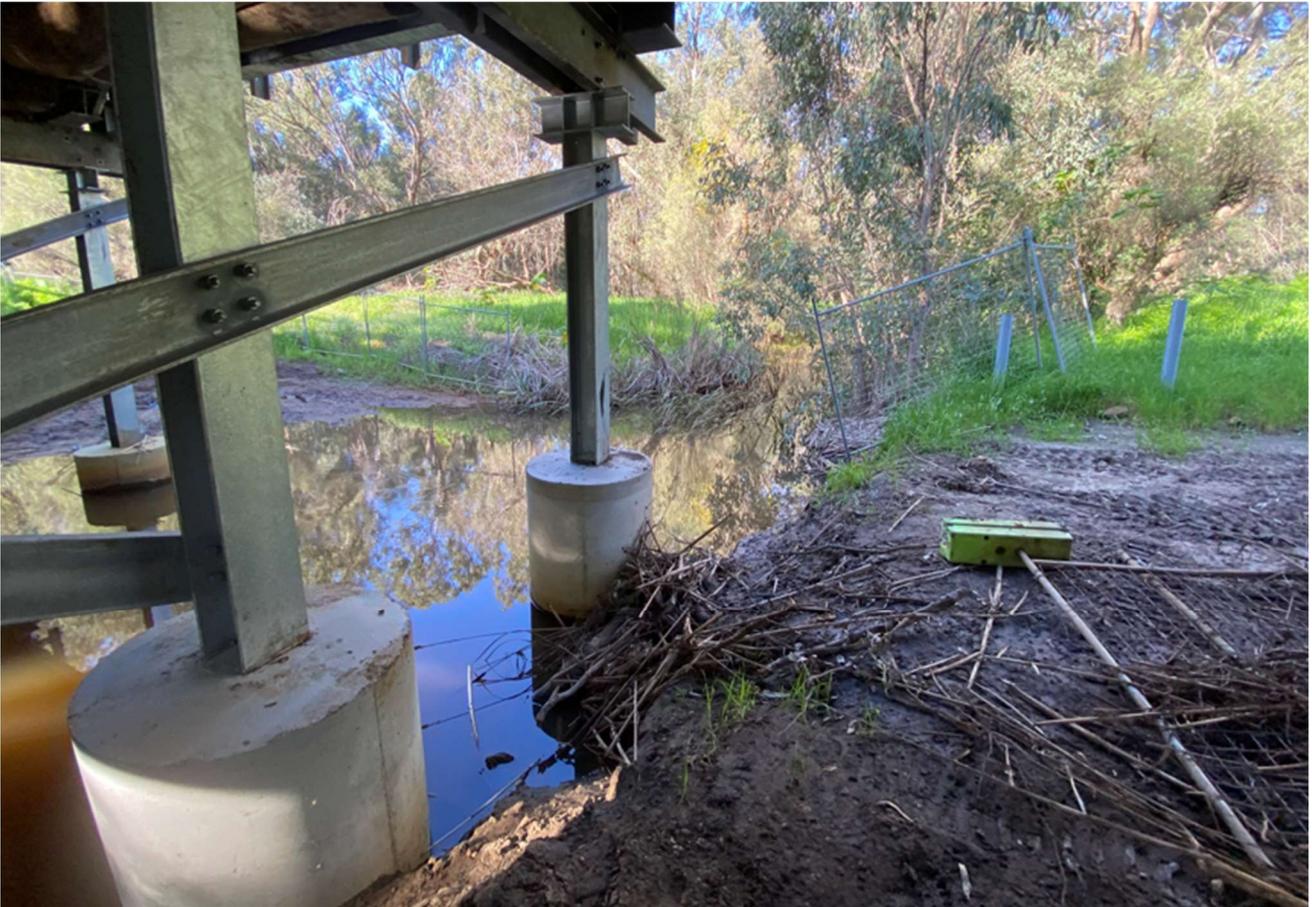
Sediment Results	
<ul style="list-style-type: none"> • Hydrocarbons, metals and nutrients detected. • Pesticides, herbicides, volatiles, surfactants and PFAS compounds not detected above the LOR. 	
Sediment – Sediment Quality DGV Exceedances	
<ul style="list-style-type: none"> • Naphthalene at 0.8 mg/kg above a DGV of 0.16 mg/kg.

Helena Roe Standing immediately downstream of Military Road bridge, looking downstream

Helena Roe Standing under Military Rd bridge, looking upstream

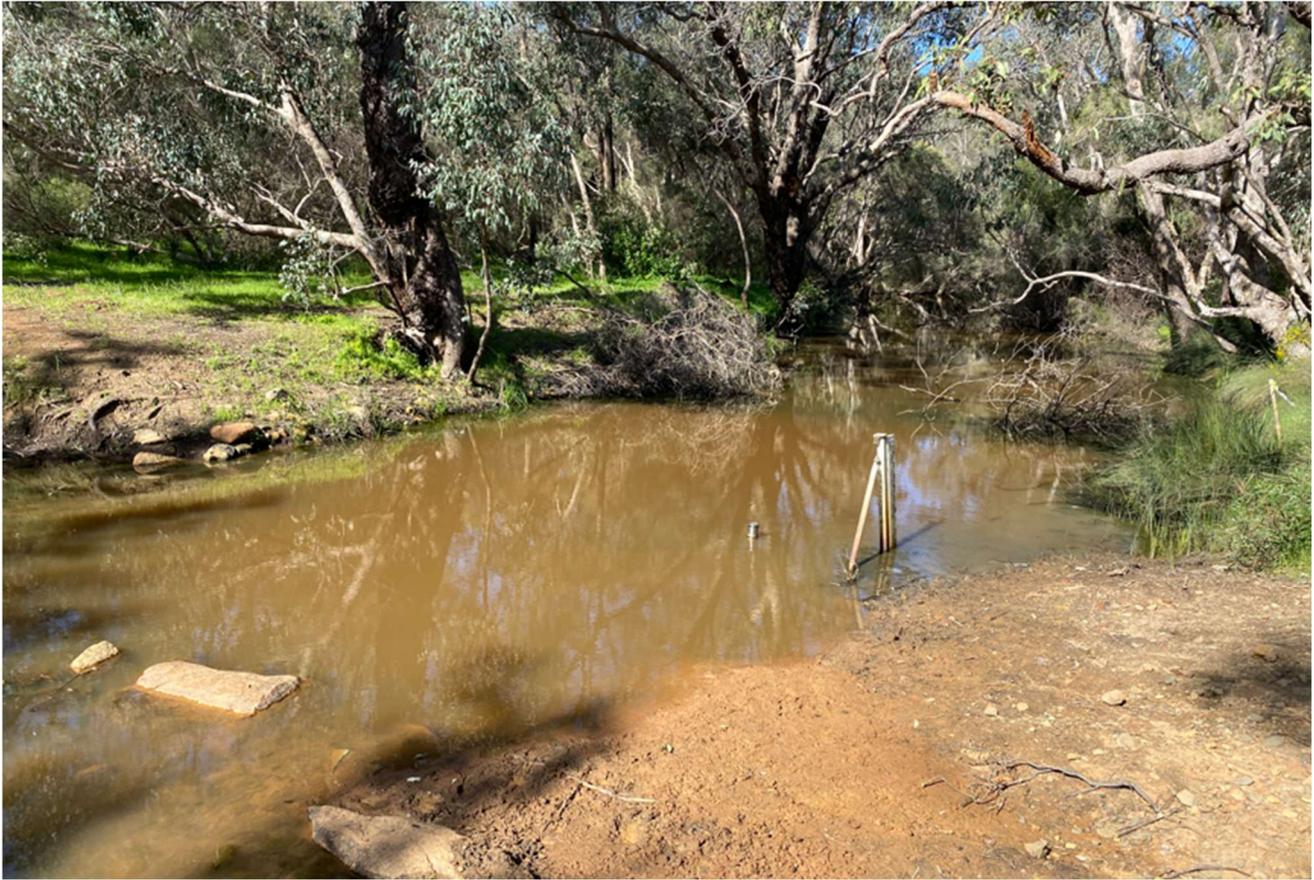
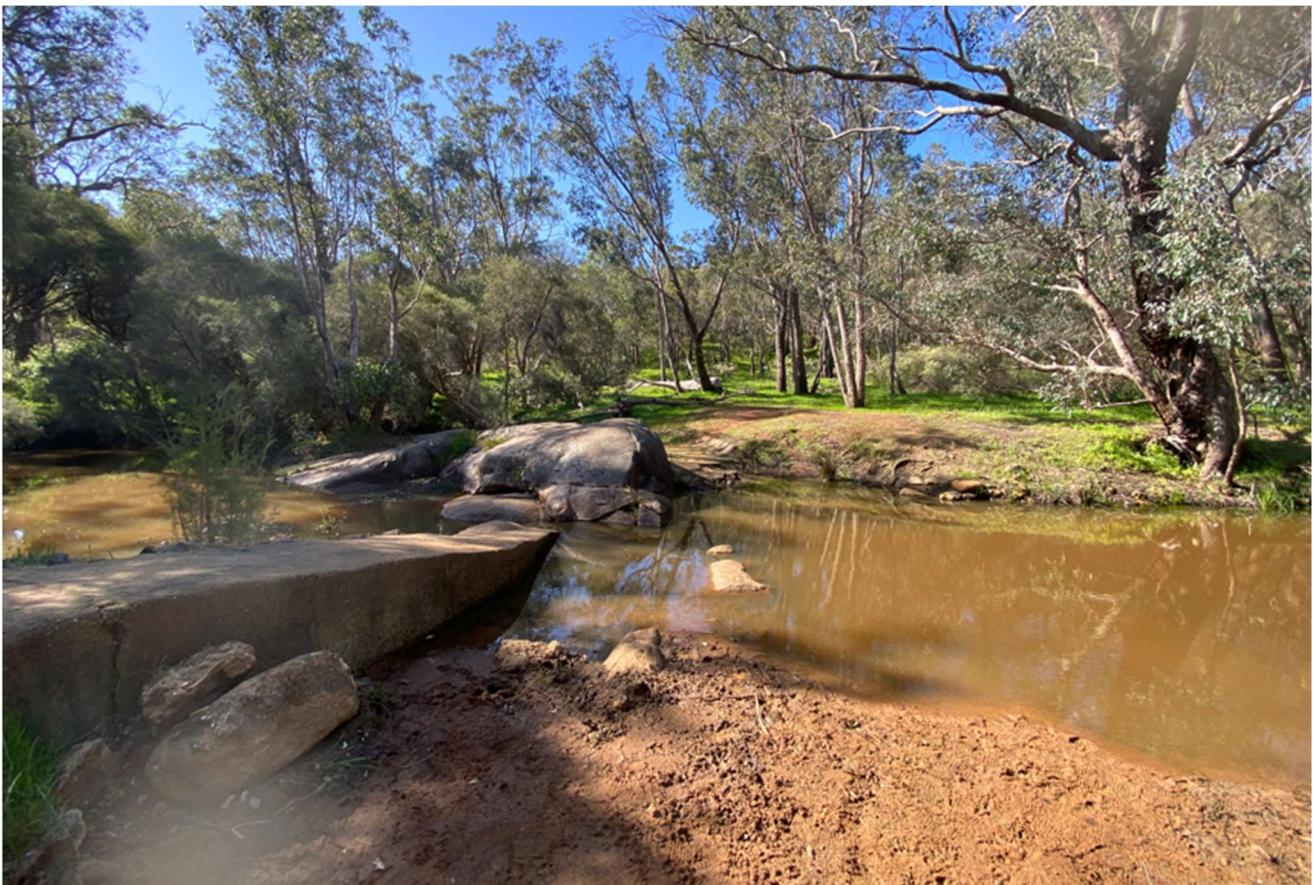
Sediment Results	
<ul style="list-style-type: none"> • Hydrocarbons, metals and nutrients detected. • Pesticides, herbicides, volatiles, surfactants and PFAS compounds not detected above the LOR. 	
Sediment – Sediment Quality DGV Exceedances	
<ul style="list-style-type: none"> • No exceedances of the DGV, although limited DGV exist to enable screening.

Craignish US Standing at Craignish Gauging Station, looking upstream

Craignish US Standing at Craignish Gauging Station, looking downstream at Craignish Weir

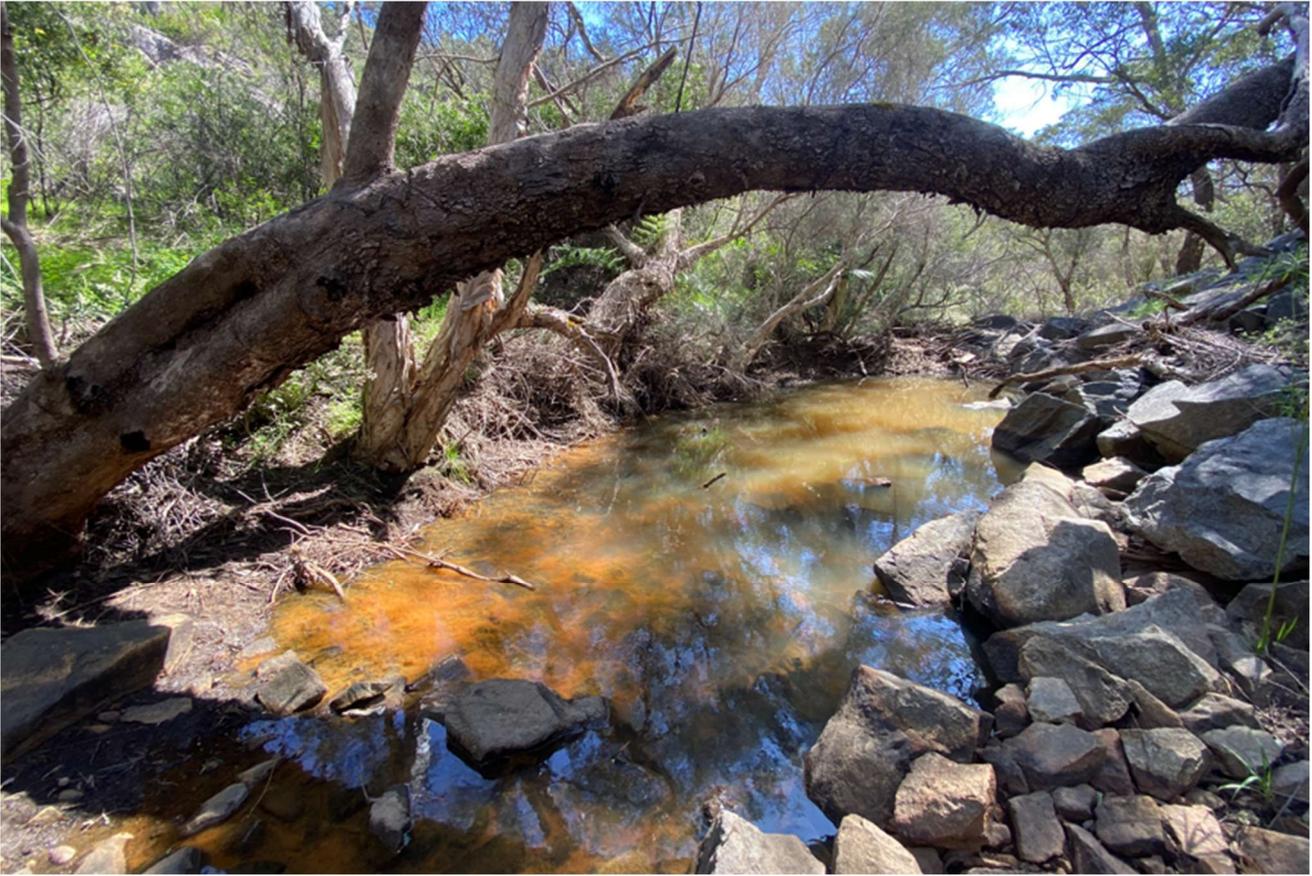
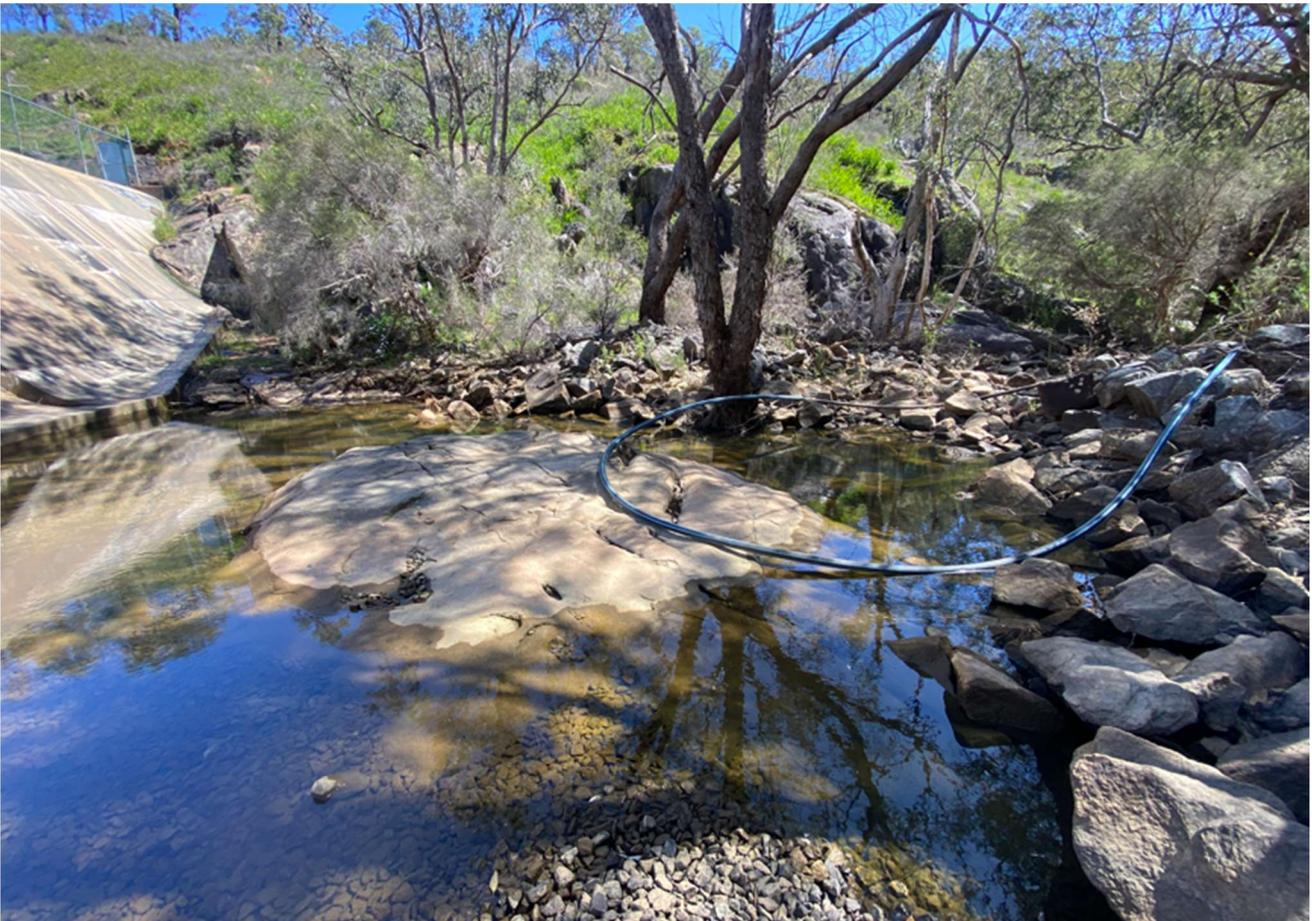
Water – Freshwater Ecosystem DGV Exceedances	
<ul style="list-style-type: none"> • Boron at 0.13 mg/L above a freshwater DGV of 0.09 mg/L. • Conductivity at 443-460 uS/cm (field-lab) above a freshwater DGV of <120-300 uS/cm. • Dissolved oxygen at 27.6% above a freshwater DGV of >80%. • <i>E. coli</i> at 150 CFU/100ml above wastewater effluent criteria of 10 CFU/100ml. • Iron at 3.4 mg/L above a freshwater DGV of 0.3 mg/L. • PFOS at 0.002 ug/L above a freshwater DGV of 0.00023 ug/L. • pH (field) at 6.49 below a freshwater DGV and wastewater effluent criteria of >6.5. 	
Sediment Results	
<ul style="list-style-type: none"> • Hydrocarbons, metals and nutrients detected. • Pesticides, herbicides, volatiles, surfactants and PFAS compounds not detected above the LOR. 	
Sediment – Sediment Quality DGV Exceedances	
<ul style="list-style-type: none"> • No exceedances of the DGV, although limited DGV exist to enable screening.

Lower Pumpback Dam Sample site in river channel downstream of LPD, looking downstream

Lower Pumpback Dam Upstream of sample site, pool at base of LPD, pipe for apparent water releases

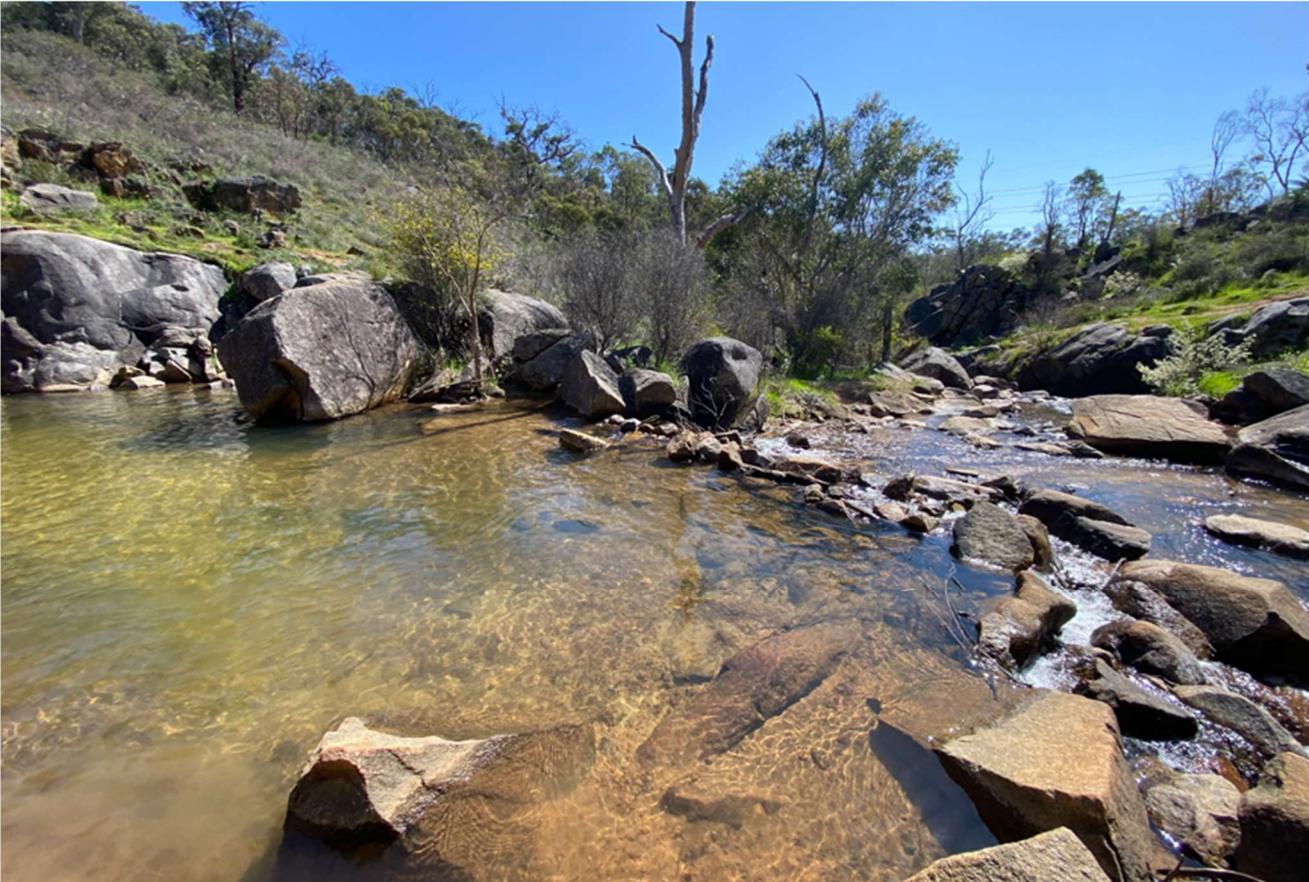
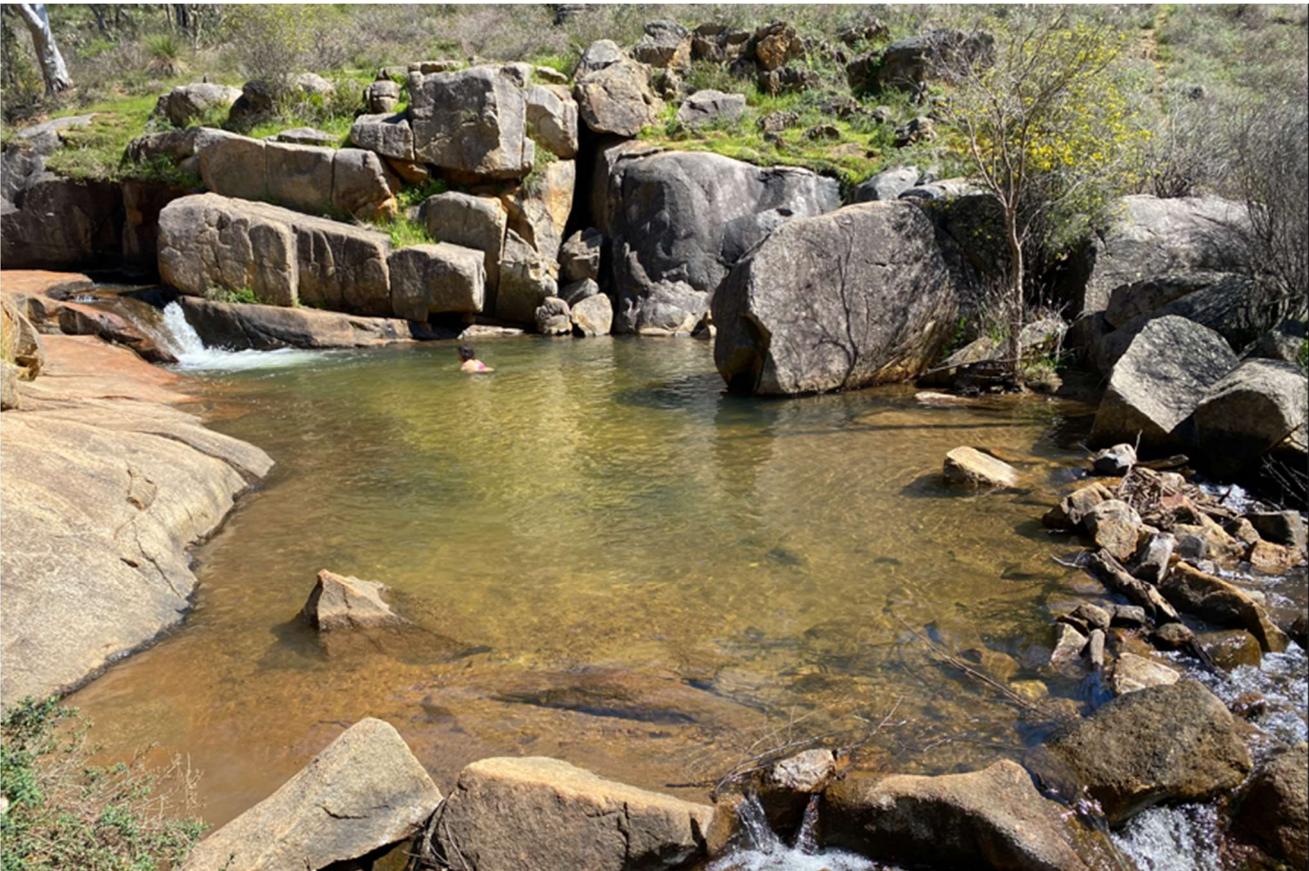
Sediment Results	
<ul style="list-style-type: none"> • Hydrocarbons, metals and nutrients detected. • Pesticides, herbicides, volatiles, surfactants and PFAS compounds not detected above the LOR. 	
Sediment – Sediment Quality DGV Exceedances	
<ul style="list-style-type: none"> • No exceedances of the DGV, although limited DGV exist to enable screening.

Rocky Pool Sample taken at the downstream point of the largest pool, looking downstream

Rocky Pool Several groups of swimmers were observed using the large pool, looking upstream

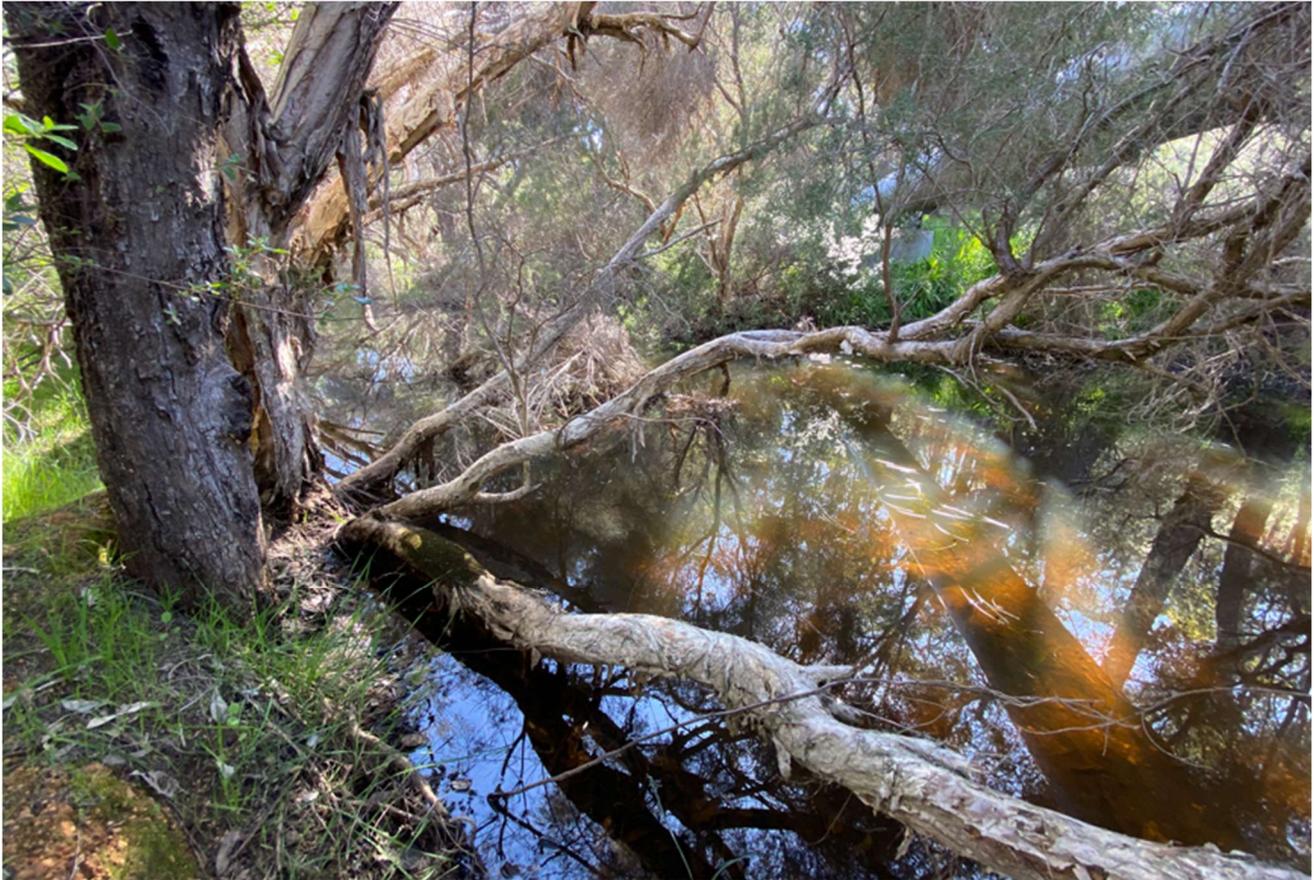
Water – Freshwater Ecosystem DGV Exceedances	
<ul style="list-style-type: none"> • Aluminium at 0.09 mg/L above a freshwater DGV of 0.027 mg/L. • Conductivity at 509–540 uS/cm (field-lab) above a freshwater DGV of <120-300 uS/cm. • <i>E. coli</i> at 12 CFU/100ml above wastewater effluent criteria of 10 CFU/100ml. • Iron at 0.9 mg/L above a freshwater DGV of 0.3 mg/L. • PFOS at 0.0006 ug/L above a freshwater DGV of 0.00023 ug/L. • Total phosphorous at 0.06 mg/L above a freshwater DGV of 0.065 mg/L. 	
Sediment Results	
<ul style="list-style-type: none"> • Hydrocarbons, metals and nutrients detected. • Pesticides, herbicides, volatiles, surfactants and PFAS compounds not detected above the LOR. 	
Sediment – Sediment Quality DGV Exceedances	
<ul style="list-style-type: none"> • TRH C10-C40 at 1,310 mg/kg above a DGV of 280 mg/kg. • Zinc at 190 mg/kg was close to a DGV of 200 mg/kg – noted but not an exceedance.

Pipe Bridge Sample taken under the pipe, looking downstream

Pipe Bridge Sample taken under the pipe, looking upstream

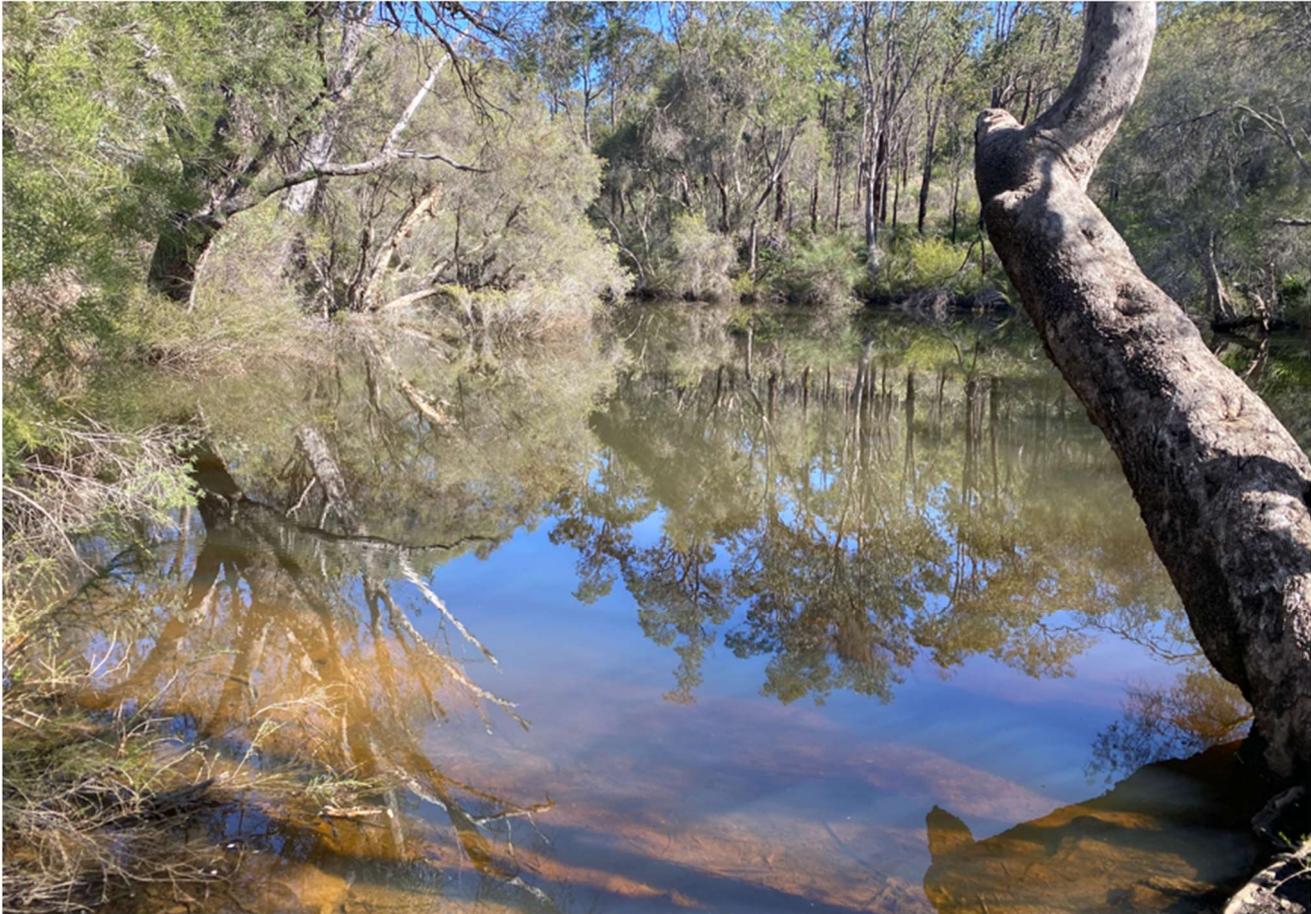
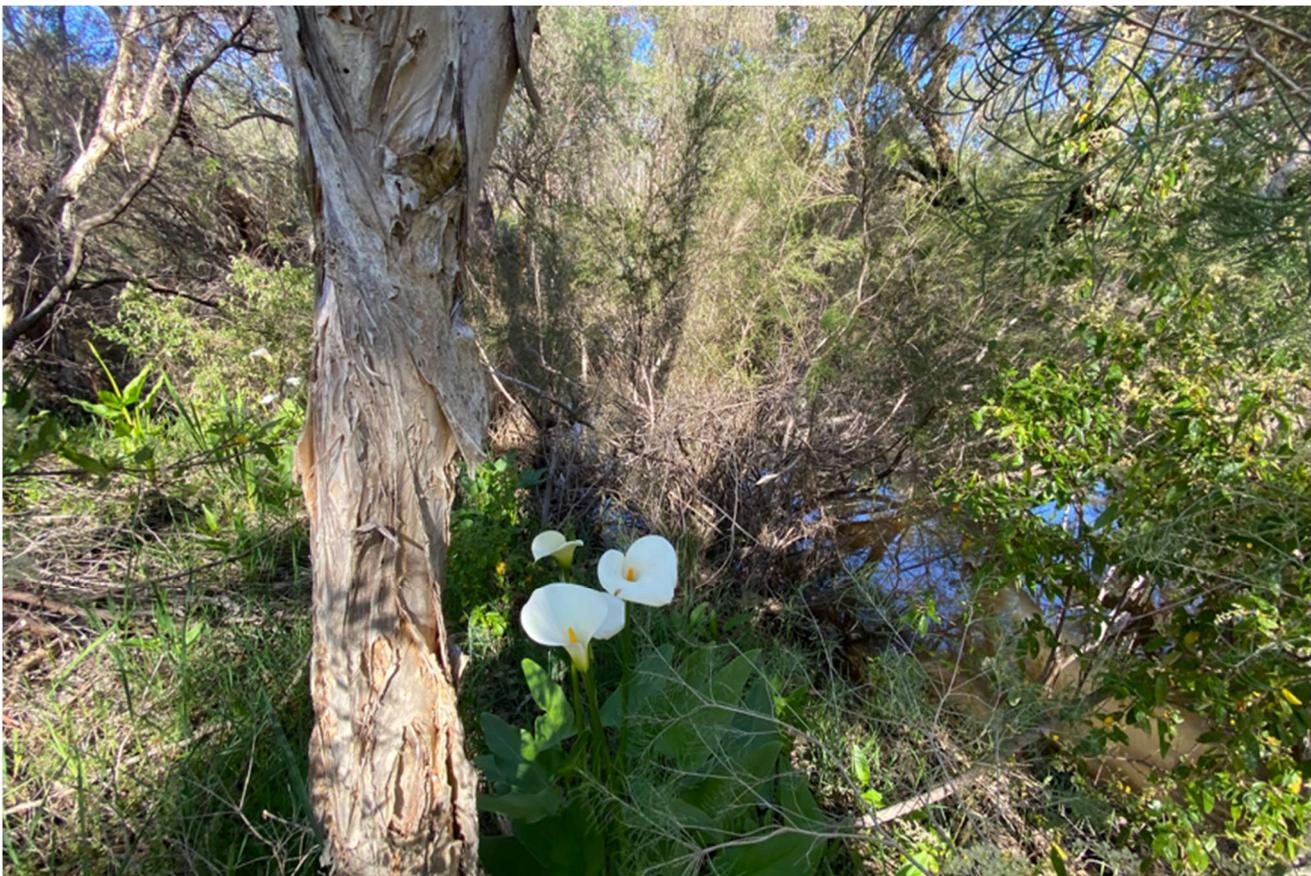
<ul style="list-style-type: none"> • TRH C10-C40 at 880 mg/kg above a DGV of 280 mg/kg.

Cobblers Pool Sample taken at northern extent of pool, looking upstream towards Gunjin Gully confluence

Cobblers Pool Banks overgrown with weeds including arum lily, looking downstream
