BoorYul-Bah-Bilya Mandoon Bilya (Helena River)

Baseline Surface Water and Sediment Sampling 2024

April 2025

Bibbul Ngarma Aboriginal Association Incorporated

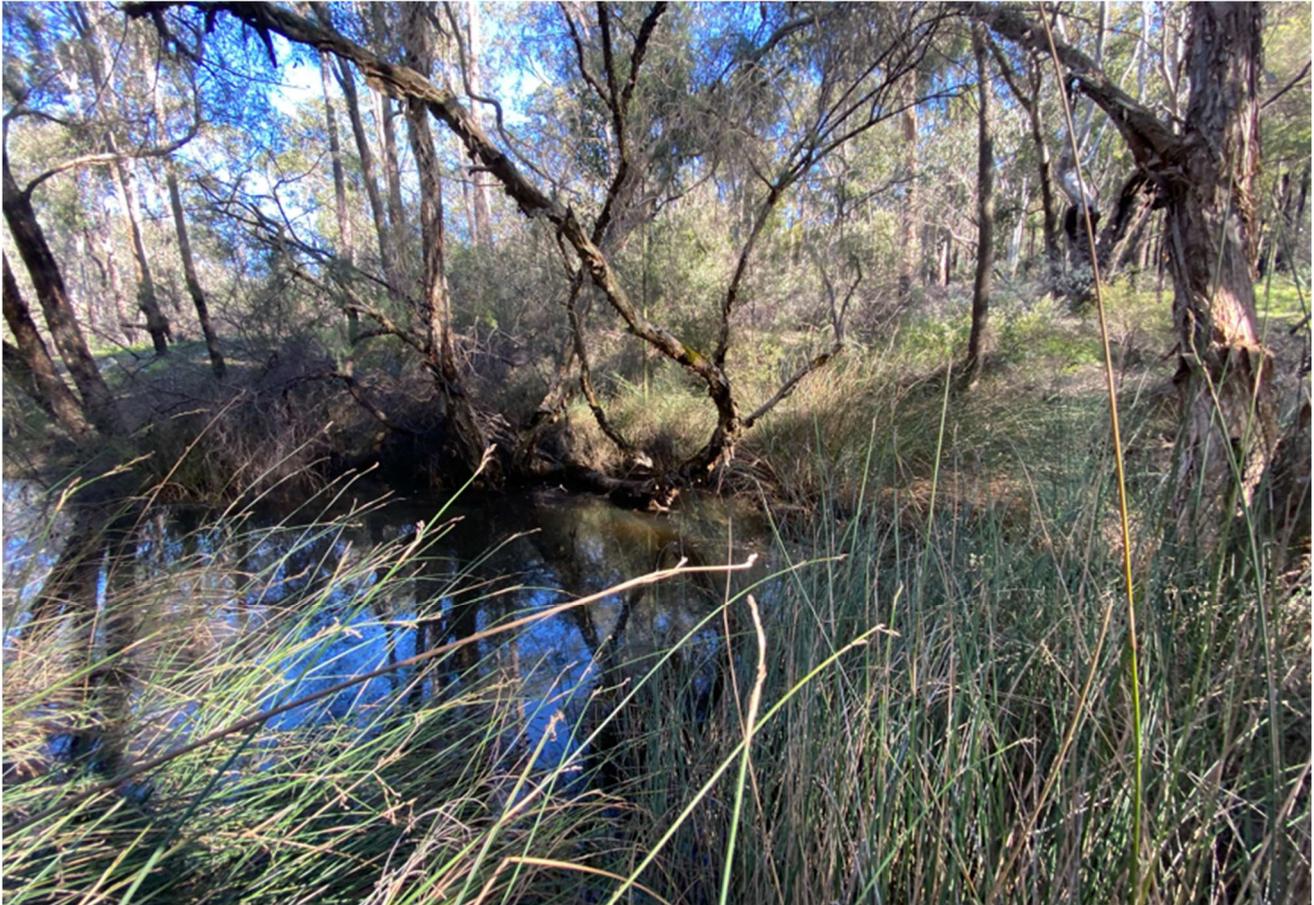
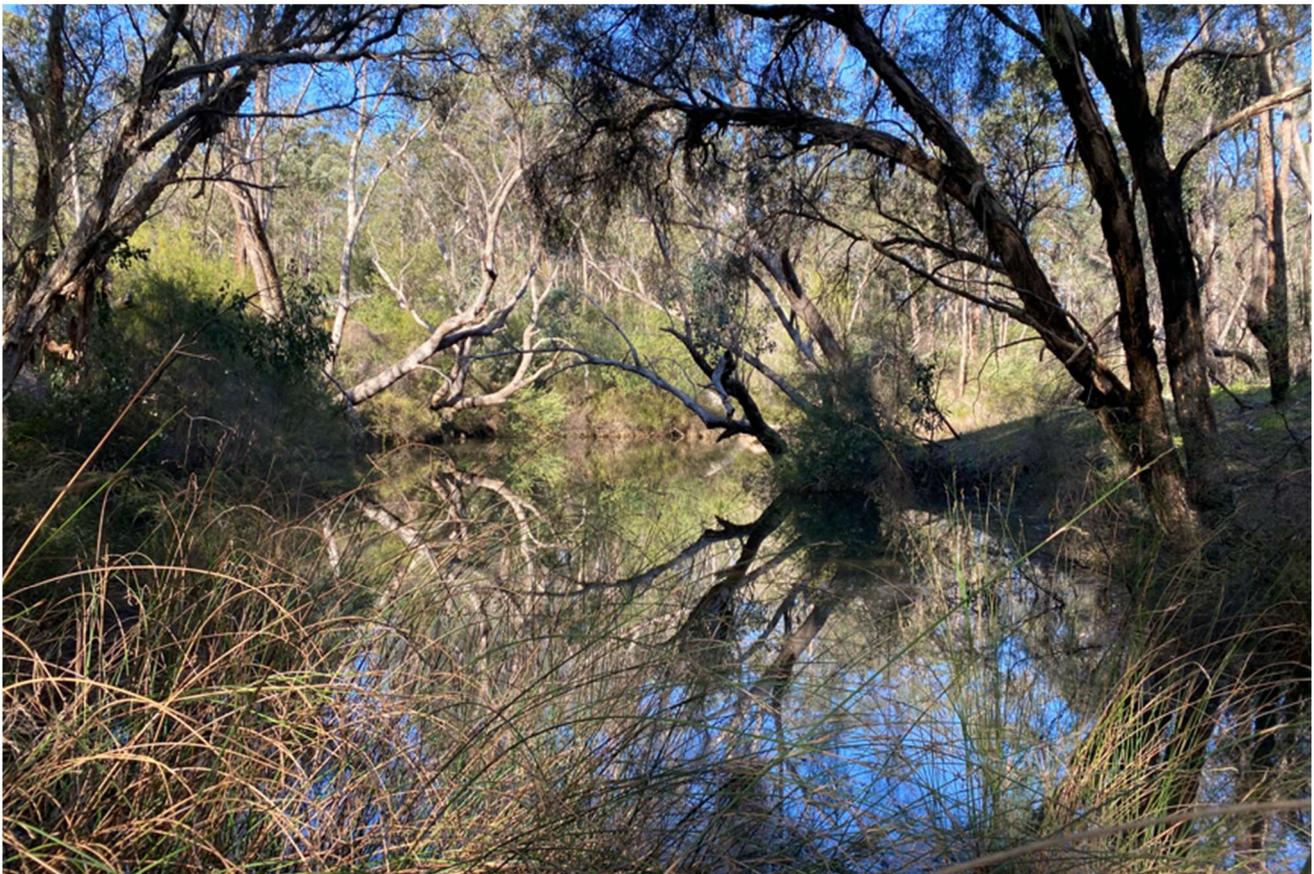
<ul style="list-style-type: none"> • TRH C10-C40 at 910 mg/kg above a DGV of 280 mg/kg.

LookSee Pool Sample taken on edge of the pool, looking downstream

LookSee Pool Sample taken on edge of the pool, looking upstream

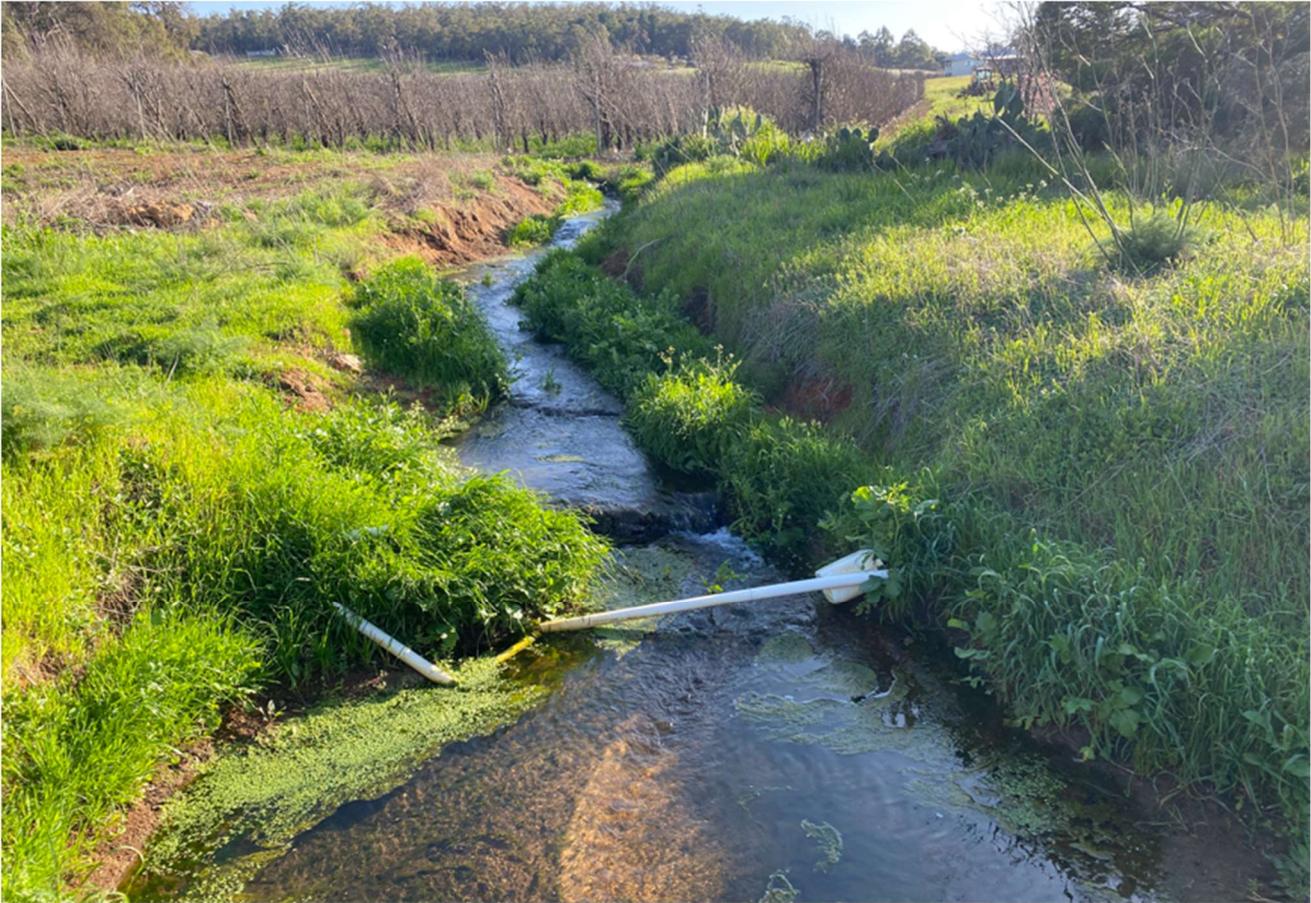
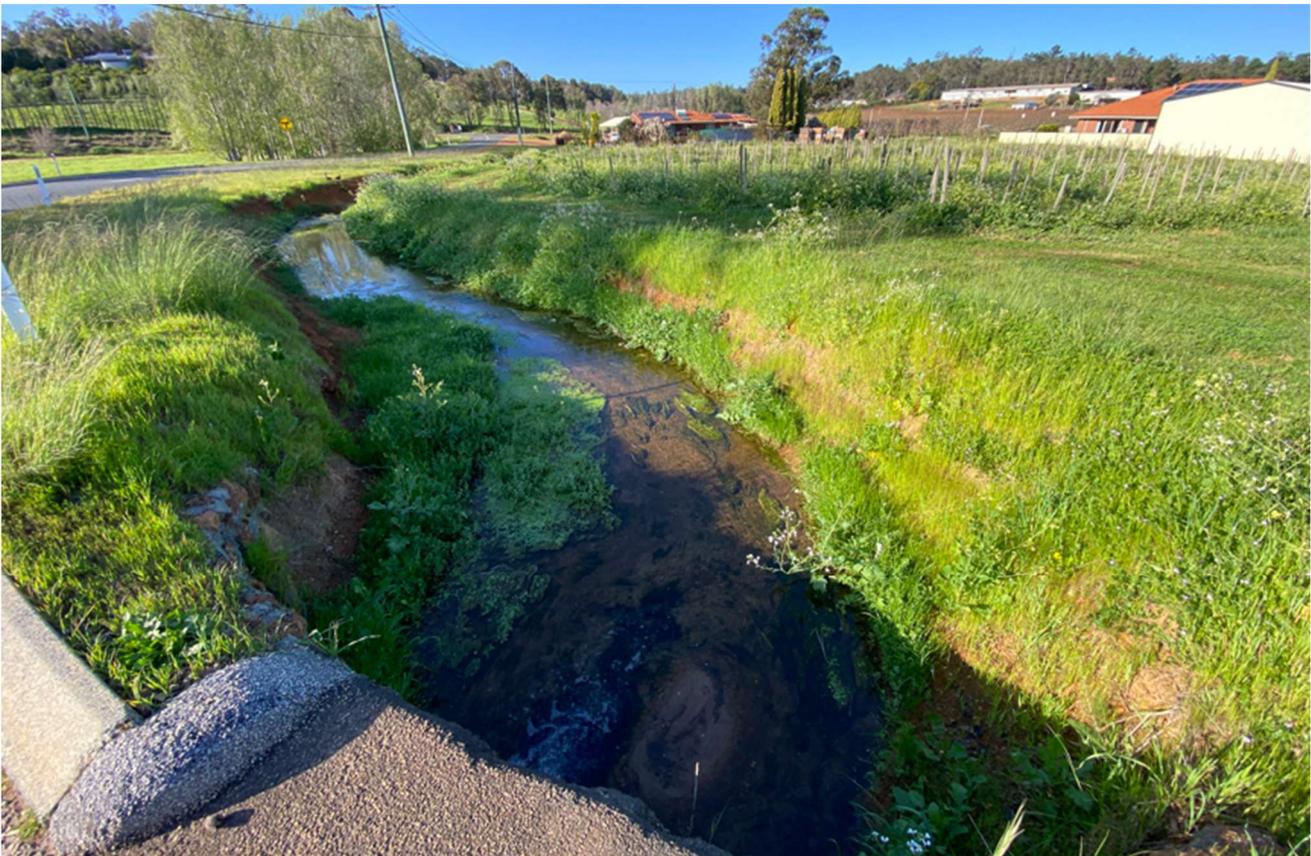
Sediment Results	
<ul style="list-style-type: none"> • Pesticides, metals, nutrients and surfactants detected. • Herbicides, hydrocarbons, volatiles and PFAS compounds not detected above the LOR. 	
Sediment – Sediment Quality DGV Exceedances	
<ul style="list-style-type: none"> • Copper at 86 mg/kg above a DGV of 65 mg/kg. • DDT at 0.03 mg/kg above a DGV of 0.0012–0.0016 mg/kg. • DDE at 0.05 mg/kg above a DGV of 0.0014–0.0022 mg/kg. • Lead at 46 mg/kg was close to a DGV of 50 mg/kg – noted but not an exceedance.

Piesse Culvert Sample taken upstream of Patterson Rd culvert, looking upstream across private property

Piesse Culvert Looking downstream from Patterson Rd across private property

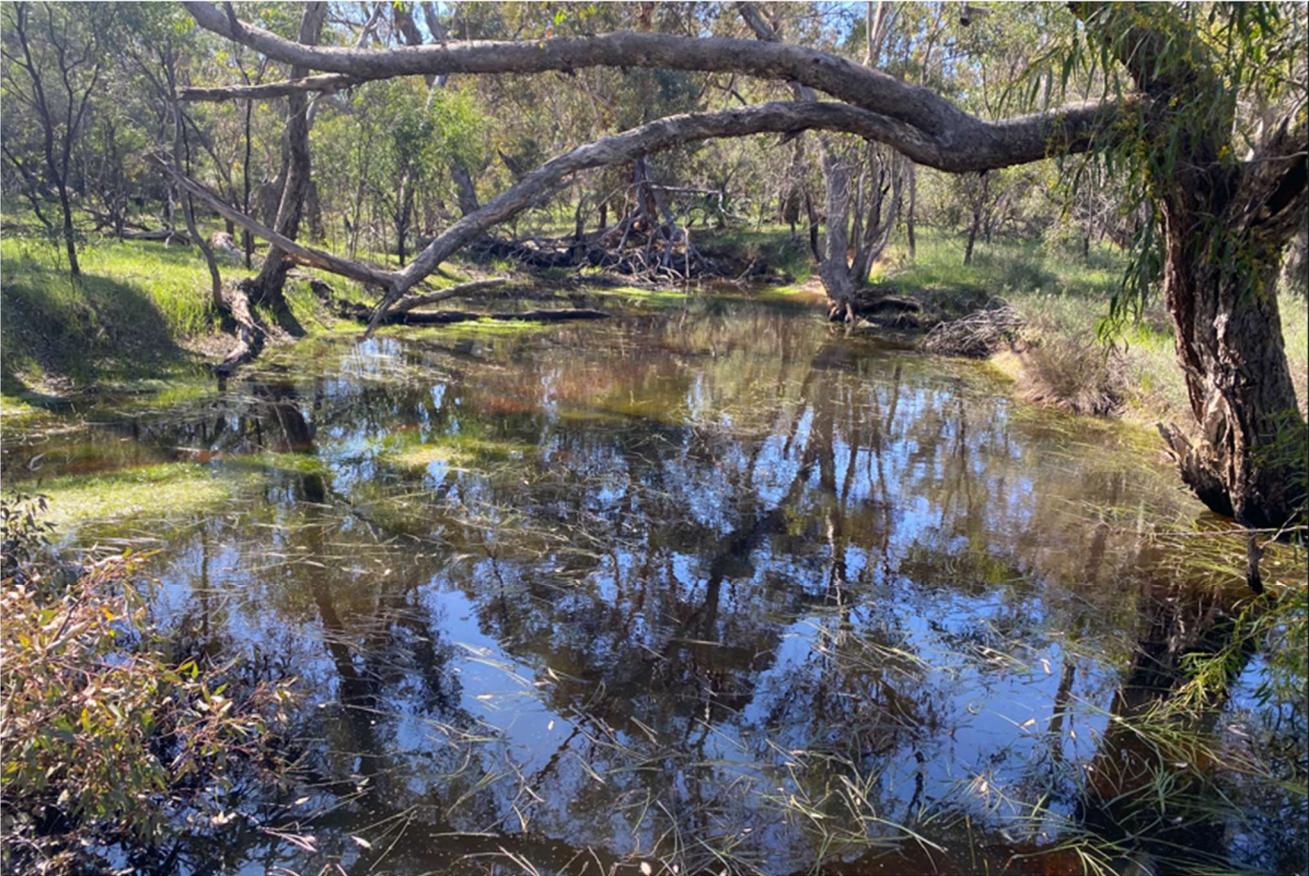
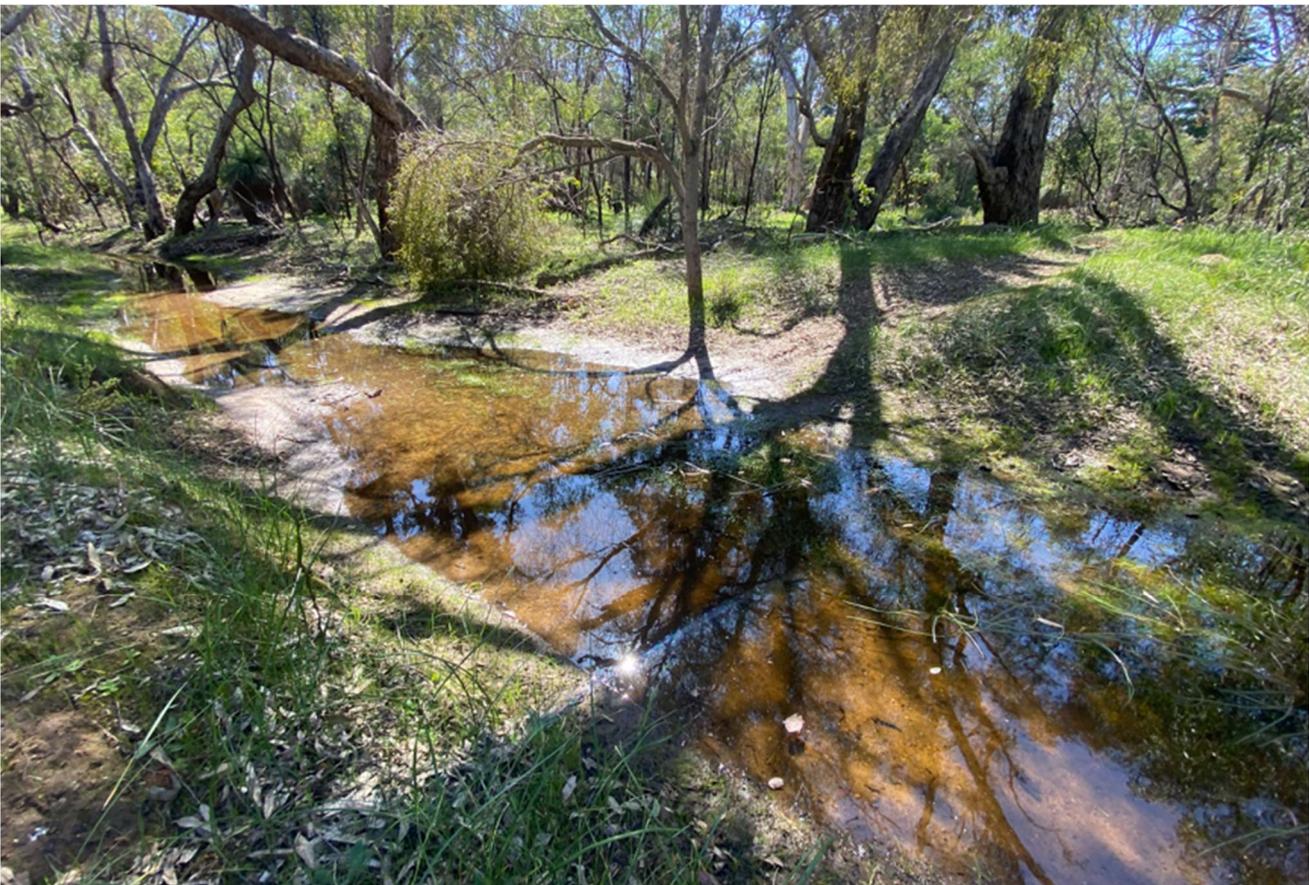
Sediment Results	
<ul style="list-style-type: none"> • Hydrocarbons, metals and nutrients detected. • Pesticides, herbicides, surfactants, volatiles and PFAS compounds not detected above the LOR. 	
Sediment – Sediment Quality DGV Exceedances	
<ul style="list-style-type: none"> • TRH C10-C40 at 990 mg/kg above a DGV of 280 mg/kg.

Salty Pool Sample taken at downstream edge of pool, looking upstream

Salty Pool Looking downstream of pool at river channel

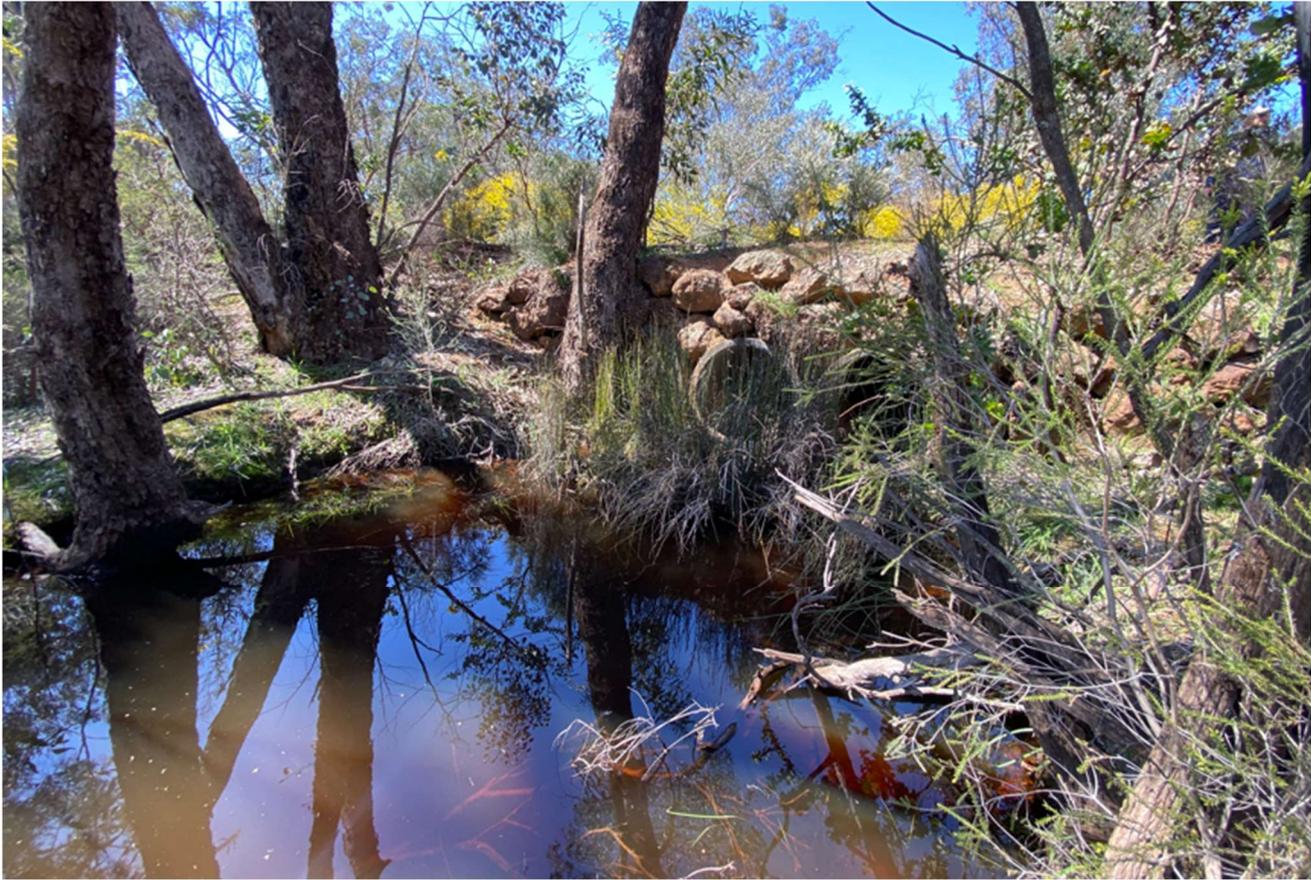
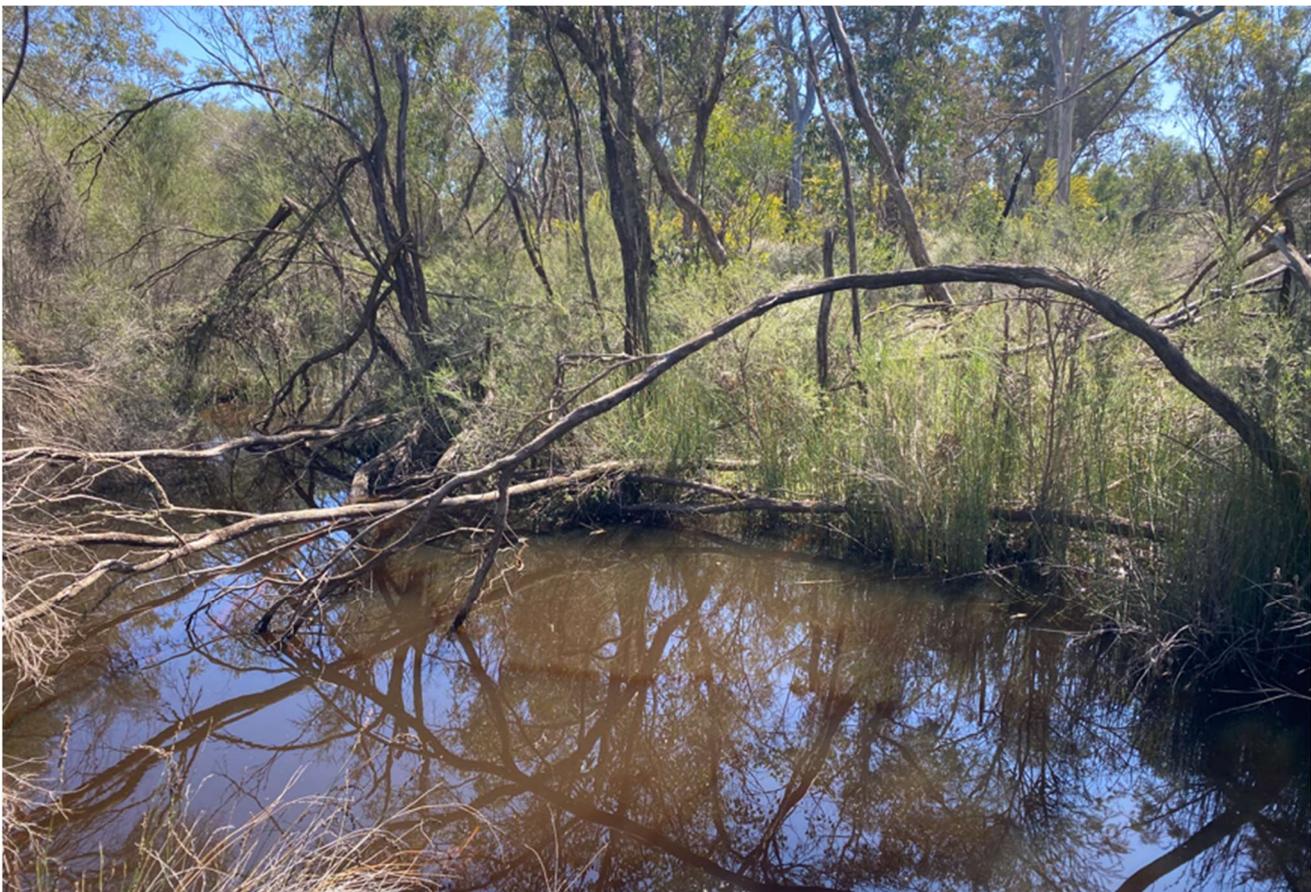
Sediment Results	
<ul style="list-style-type: none"> • Hydrocarbons, metals and nutrients detected. • Pesticides, herbicides, surfactants, volatiles and PFAS compounds not detected above the LOR. 	
Sediment – Sediment Quality DGV Exceedances	
<ul style="list-style-type: none"> • No exceedances of the DGV, although limited DGV exist to enable screening.

Beraking Yarra Sample taken downstream of Yarra Road culvert, looking upstream

Beraking Yarra Sample taken downstream of Yarra Road culvert, looking downstream
